THE INFLUENCE OF THE WELDING PROCESS ON THE QUALITY OF WELDED JOINTS

Almaida Gigović-Gekić, Elvis Agović
Faculty of Engineering and Natural
Science, University of Zenica
Bosnia and Herzegovina

ABSTRACT

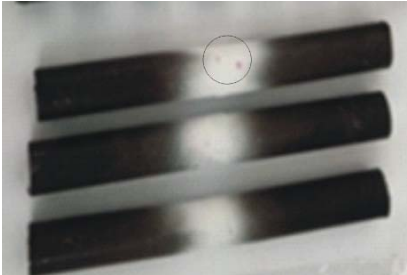
Liquid penetrant examination is one of the most popular Nondestructive Examination (NDE) methods in the industry. This method is used to detect surface defects such as micro and macro cracks on the surface, porosity, and the similar defects on non-porous materials. Testing with liquid penetrants is based on capillary phenomena, i.e. the property of liquid to rise and penetrate narrow free spaces-capillaries. The test procedure consists of cleaning the surface to be tested, then applying a liquid penetrant with high wetting ability and capillarity that penetrates on surface discontinuities. Excess liquid is removed from the surface, and then a developer (powder) is applied to "draw" the trapped penetrant from the discontinuity to the surface of the component where it becomes visible. The test was carried out before and after machine processing of the test pieces for the tensile testing. Surface cracks were observed on the test pieces that were tested before machining, Figure 2. No cracks were observed on the machined test pieces, Figure 3.

Figure 2. Test pieces before machining

delta ferrite content were also examined. Welding was done using the TIG process in a protective argon atmosphere, with 316L AISI steel used as a filler metal. Liquid penetrant examination detected the presence of surface cracks, but these cracks were removed during sample preparation for tensile testing by machining. Analysis of the delta ferrite content showed an increased delta ferrite content in the weld metal compared to the base metal. Macrostructure analysis indicated a butt joint with partial penetration. The microstructure was austenitic, with the presence of carbides and delta ferrite. The tensile strength of the welded sample was lower than that of the base metal, but the proof strength was in accordance with standard A276. The lower tensile strength values were due to imperfections in the weld metal, where the specimen fracture occurred. Lack of penetration was identified as the primary reason for the reduced strength of the weld metal. This type of welding can be applied in less critical structures that are not highly loaded, especially those not subjected to dynamic loads.

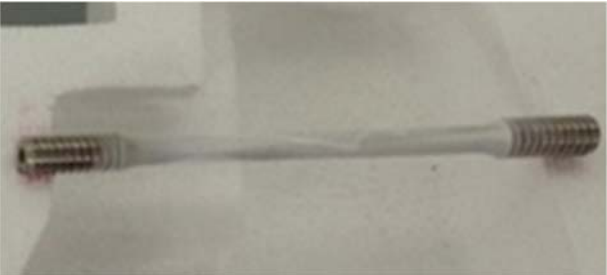
Figure 3. Test pieces after machining

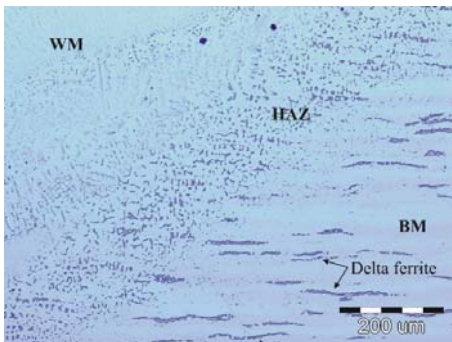
As part of the metallographic tests, an analysis of the microstructure of the samples was carried out on an optical microscope OLYMPUS BX60M after the welding process (Figures 5 and 6). Before the microstructure analysis, the test pieces were prepared by grinding, polishing, and etching. Kaling #2 (100 ml HCl, 5 g CuCl₂, and 100 ml C₂H₅OH) was used for etching because a ferrite attacked rapidly and austenite slightly.

Figure 5. Microstructure sample No. 1, Kalling #2, 100x

From Figure 6 it could be seen the presence of delta ferrite in the base metal of sample No.1. The presence of delta ferrite in the sample No.2 is hardly noticeable. The precipitated carbides form strings along the grain boundaries and are precipitated at the austenite/delta ferrite phase boundary. In austenitic stainless steels, chromium carbides already precipitated when steel was heated from 550°C. The microstructure of the weld metal is a cast microstructure. The weld metal has an austenitic microstructure with interdendritic and/or intercellular ferrite (AF model). That is, during solidification, austenite first forms, and delta ferrite is formed by eutectic reaction from the remaining melt between the austenite dendrites [18]. The delta ferrite content depends primarily on the chemical composition of a weld metal not so much on the chosen welding process parameters.

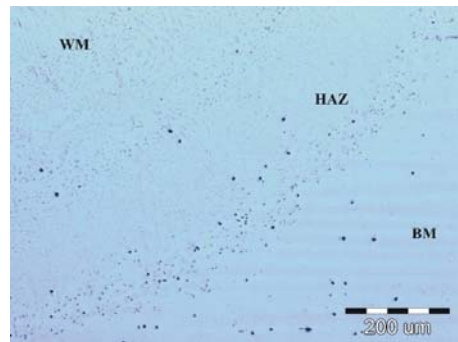
Figure 6. Microstructure sample No. 2, Kalling #2, 100x

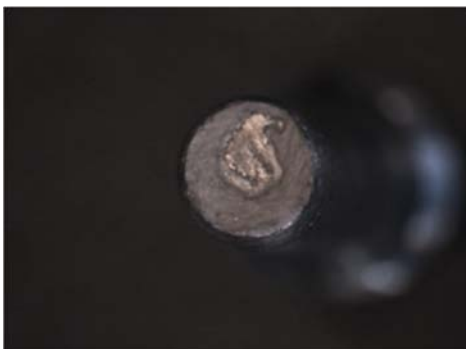
Figure 7. Example of the fracture surfaces of the tensile test pieces for Sample No.1, 6,3x

From the obtained results, it can be seen that samples No.1 have higher strength compared to samples No.2, which may be influenced by the increased delta ferrite content in these samples. However, when comparing the results with the tensile strength of the base material, which according to the A276 standard exceeds 655 N/mm², none of the samples meet the requirement. Unlike the tensile strength values, the yield strength is in accordance with the standard, which prescribes a value greater than 345 N/mm². The fracture location in all specimens is at the weld, and the analysis of the fracture surface revealed insufficient penetration, with the imperfection length being approximately 4 mm, Figure 7 and 8. Given the specimen diameter of 7.9 mm, this represents a significant defect. The fracture surfaces indicate that the failure mode is ductile fracture. Lack of penetration is a fabrication-related defect and can be prevented by: avoiding an excessively large root face, ensuring an adequate root gap and using a sufficiently high welding current [16]. The analysis of the macrostructure and tensile strength testing showed that the butt joint method with partial penetration weld was used during welding. Unlike full penetration weld, this method is used when maximum load-bearing capacity is not required and when the components are not exposed to dynamic loads. Additionally, this method is more economical due to lower consumption of filler material and simpler joint preparation.

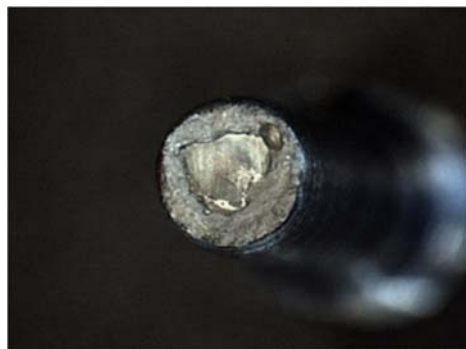
Figure 8. Example of the fracture surfaces of the tensile test pieces for Sample No.2, 6,3x
